DIGITAL MultiSwitch Fast Ethernet Switch 924TXG Release Notes Version 1.1.1 April 2000

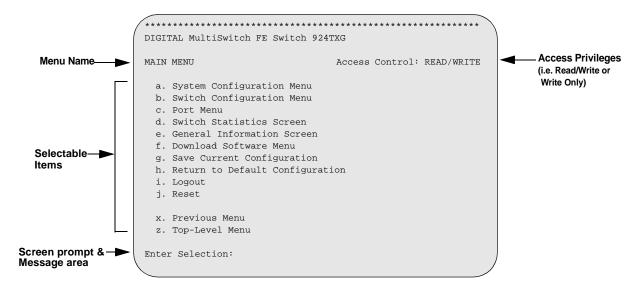
From the module's installation menu, type f to view the Main Menu selections as described below.

Selection	Description
System Configuration Menu	Contains commands and parameters that reflect the global configuration of the switch related to management.
Switch Configuration Menu	Provides access to information and parameters affecting the function of the switch, for instance, the movement of packets through the switch. For example, you can configure Forwarding Table, Spanning Tree, and virtual LANs (VLANs).
Port Menu	Shows the configuration of the individual ports on the switch and allows you to modify switch port operation.
Switch Statistics Screen	Presents switch-level and port-level statistics.
General Information Screen	Displays the system software version, switch serial number, base MAC address, system up time and power-up count.
Download Software Menu	Contains parameters and commands for initiating a software download to upgrade the switch operating software.
Save Current Configuration	Saves current switch operating parameters to non-volatile memory.

Return to Default Configuration	Restores switch operating parameters to factory defaults. You must re- set the switch for activate default parameters.
Logout	Logs out of the Telnet interface. Once you logout, you must enter a password before you can access the Telnet interface again. Note: this menu item is only seen from within a Telnet session.
Reset	Performs a software reset of the switch by restarting the system soft- ware and reloading all operating parameters.
Previous Menu	Returns you to the previous menu.
Top-Level Menu	Returns you to the top-level menu.
